**Field Oversight Report
U.S. Moorings Substantial Product Investigation
Gasco Sediments Site, Portland, Oregon**

**Work Assignment No.: 336-VOEE-10EW
Gasco/Siltronics
EPA RPM: Sean Sheldrake
CDM Smith Project Manager: Lance Peterson**

February 5, 2014

**Prepared by:
CDM Federal Programs Corporation
555 17th Street, Suite 1100
Denver, Colorado 80202**

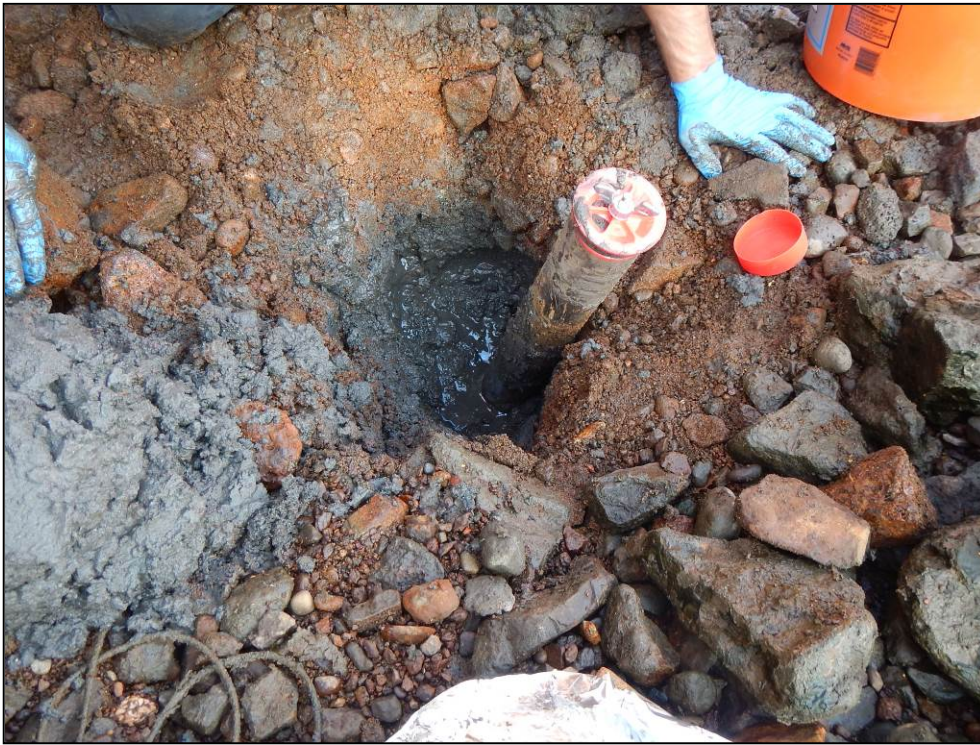
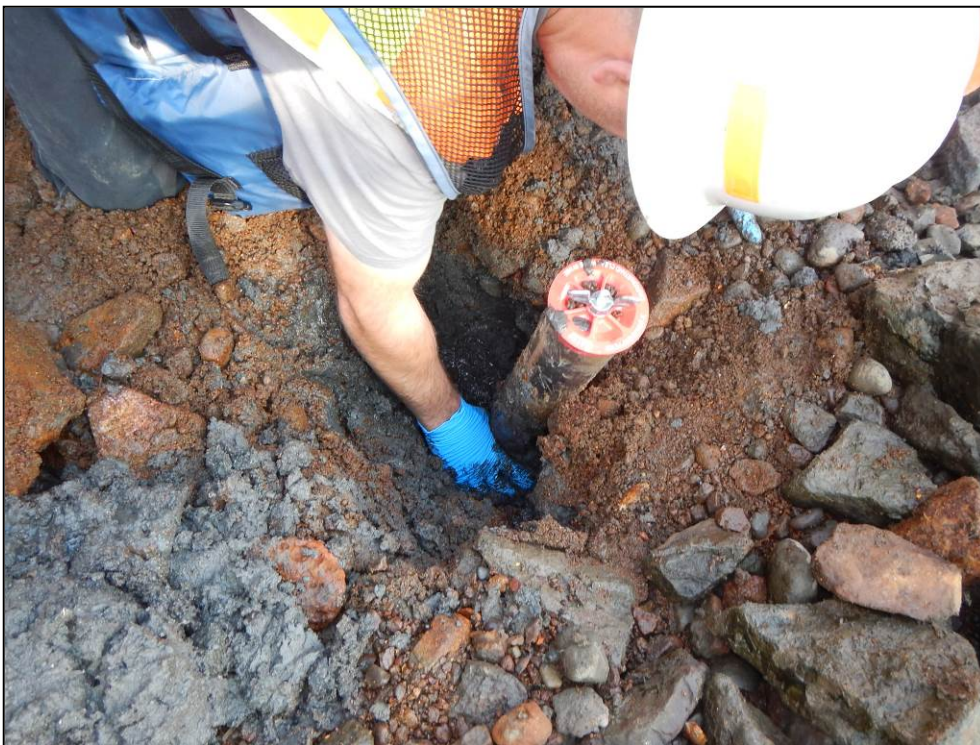
Core GS-01-AQ Core Location and Excavation (1st attempted core)

The excavation around the first attempt core reached a maximum measured depth of 2 feet 7 inches bml (which includes the 5 inches of cobbles removed prior to advancing the core tube) before the sidewalls began to slough due to the influx of water. No black staining was observed along the sidewalls and no odor was noted. A sheen was observed on the surface of the water within the hole. Some black mottling was observed in some of the sediment removed from the excavation, but these

were few and sporadic, and no odor was noted from these black pockets. The black coloring appeared to be related to organics.

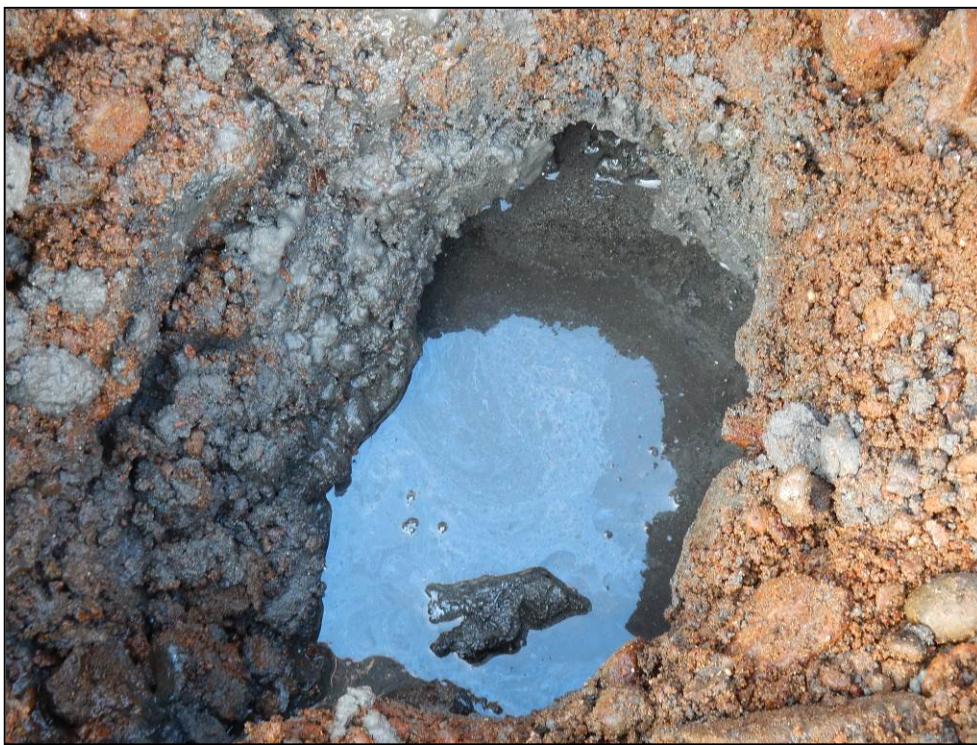
GS-01-AQ No substantial product identified.
 Sediment Core Recovery: 1.6 feet
 Maximum Excavation Sidewall Depth Observed: 2.6 ft bml
 Field Evidence of Contamination Observed in Core or Sidewall:
 No field evidence of substantial product observed. No black bands or layers
 observed. No odors noted in core or excavation. Slight sheen observed on water in
 excavation hole.

GS-01 Location – Sheen on water in excavation hole (1st attempted core location)

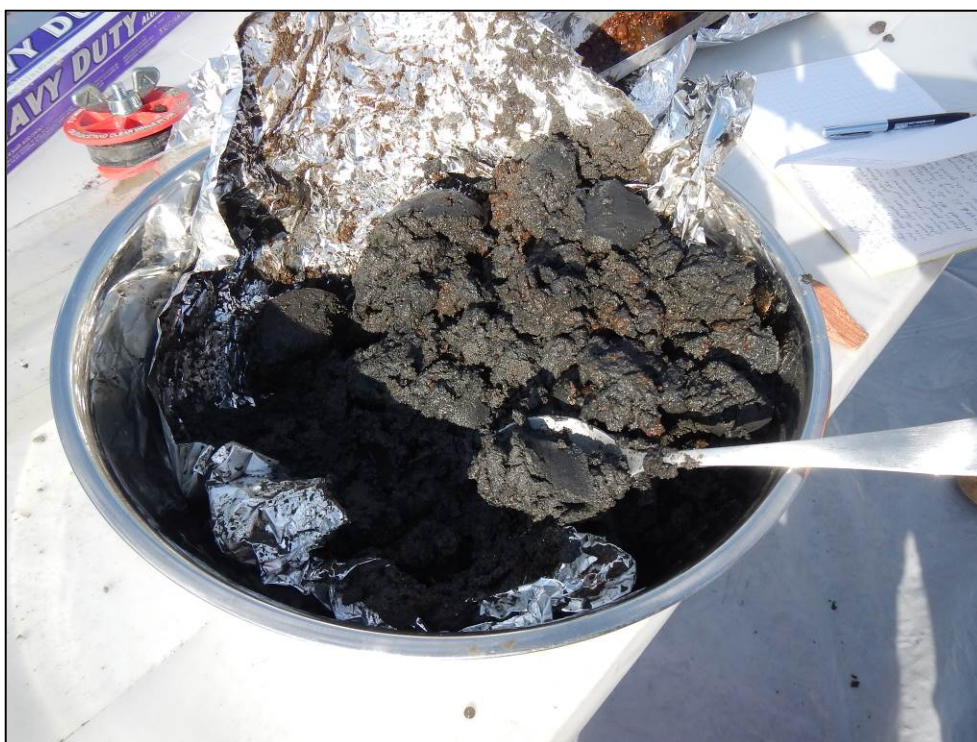
Core GS-01-AQ: Sediment removed during excavation to remove core from subsurface

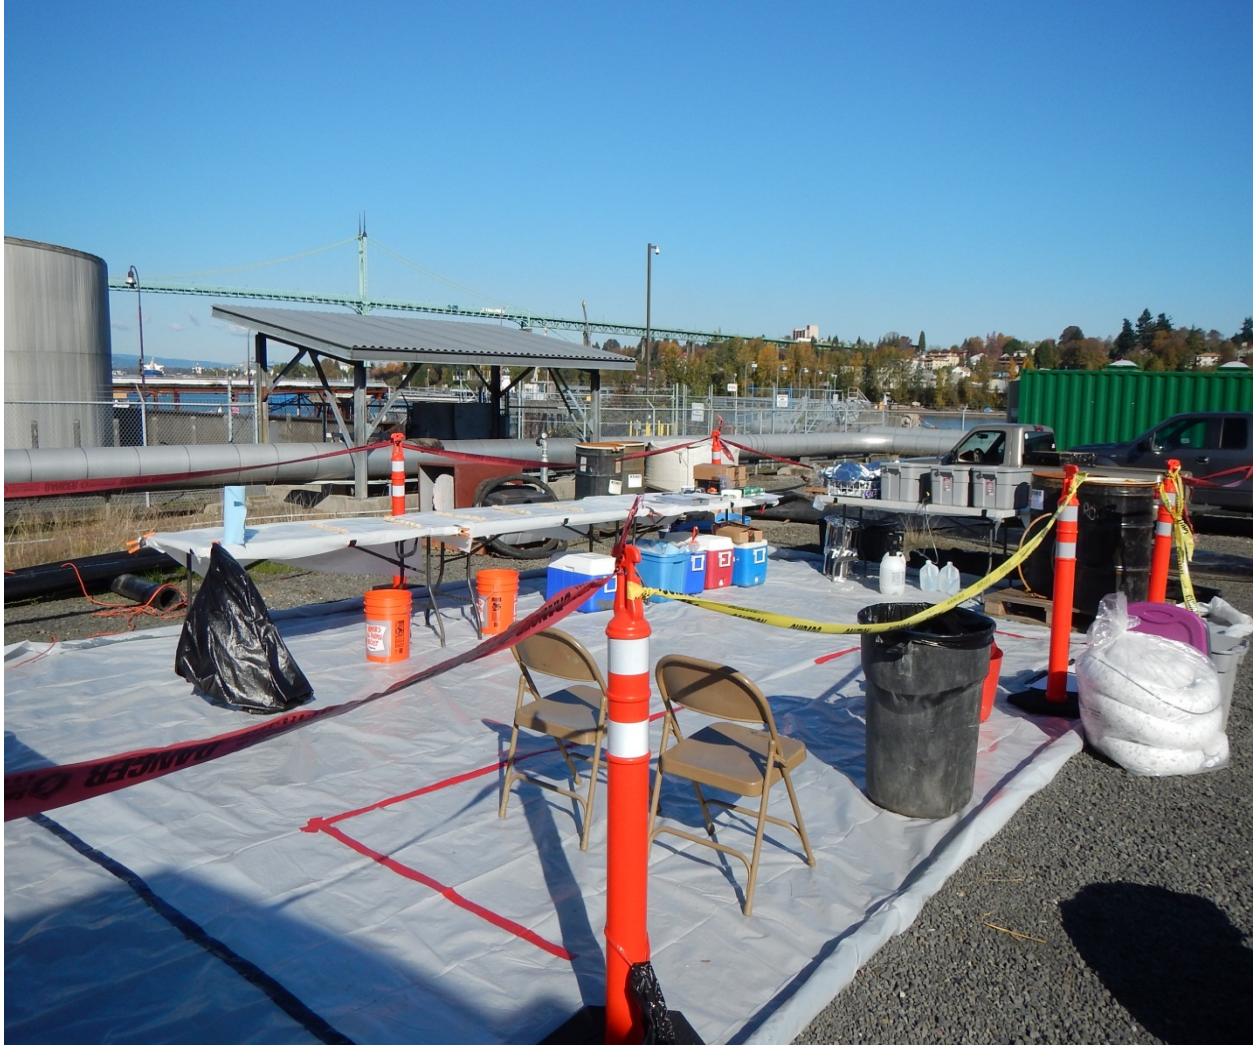
Photo 1: Setup of core processing location on the Gasco site upland.

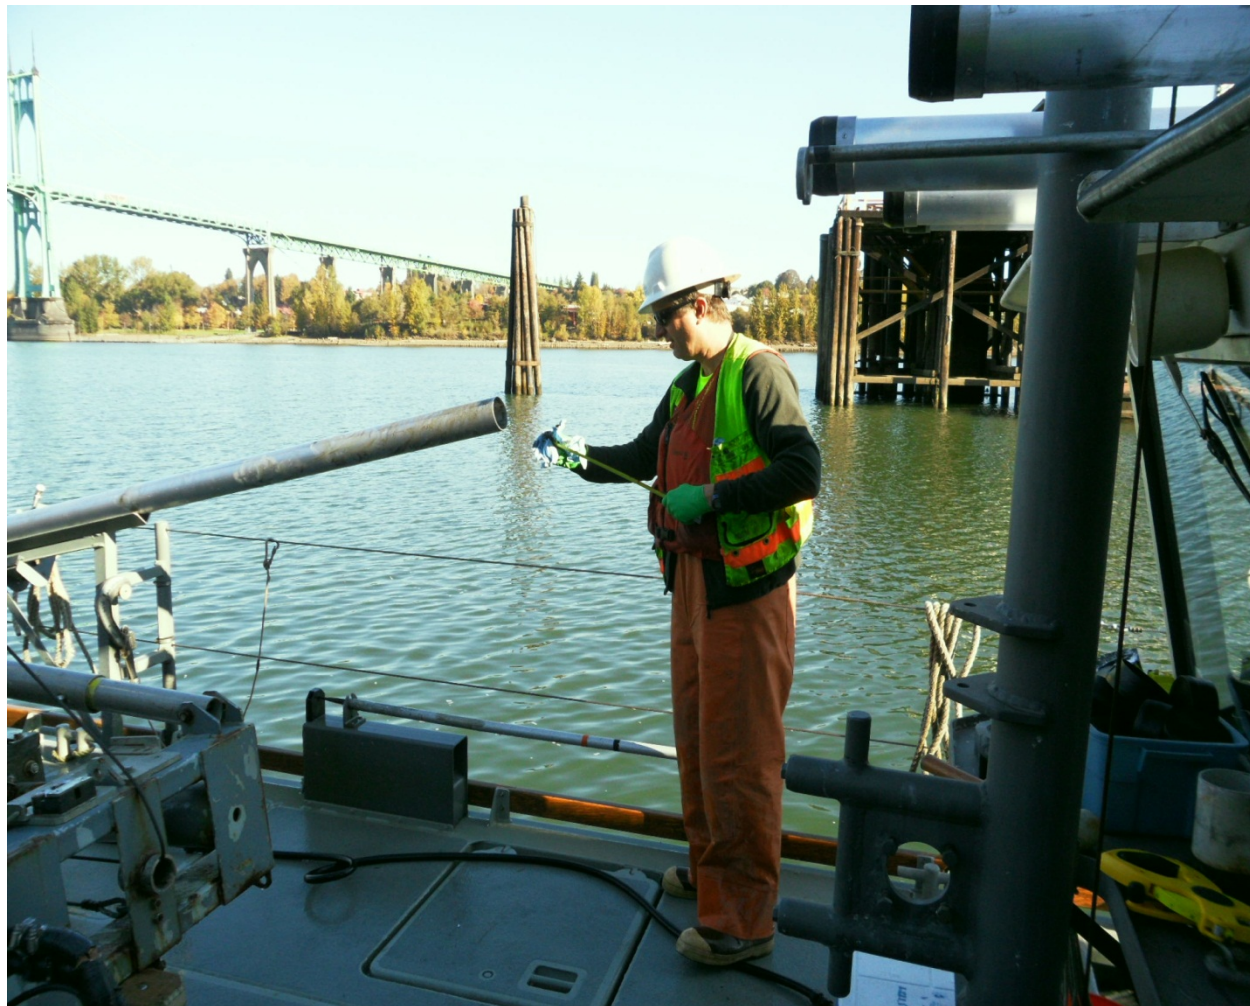
Photo 2: Offshore sample collection and data recording on Vibracore vessel.

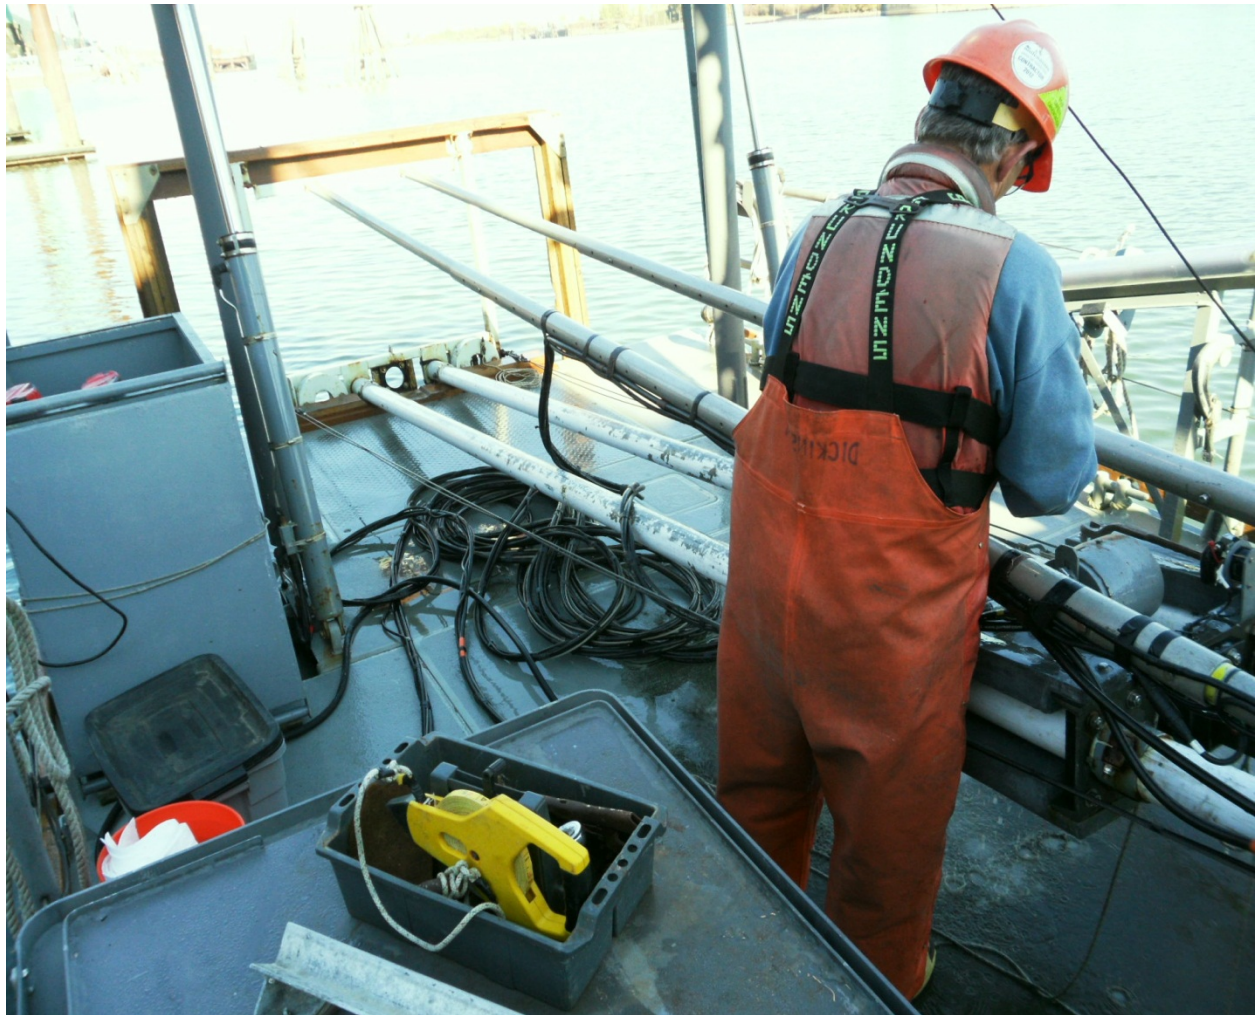
Photo 3: Preparing Vibracore equipment for sampling activities.

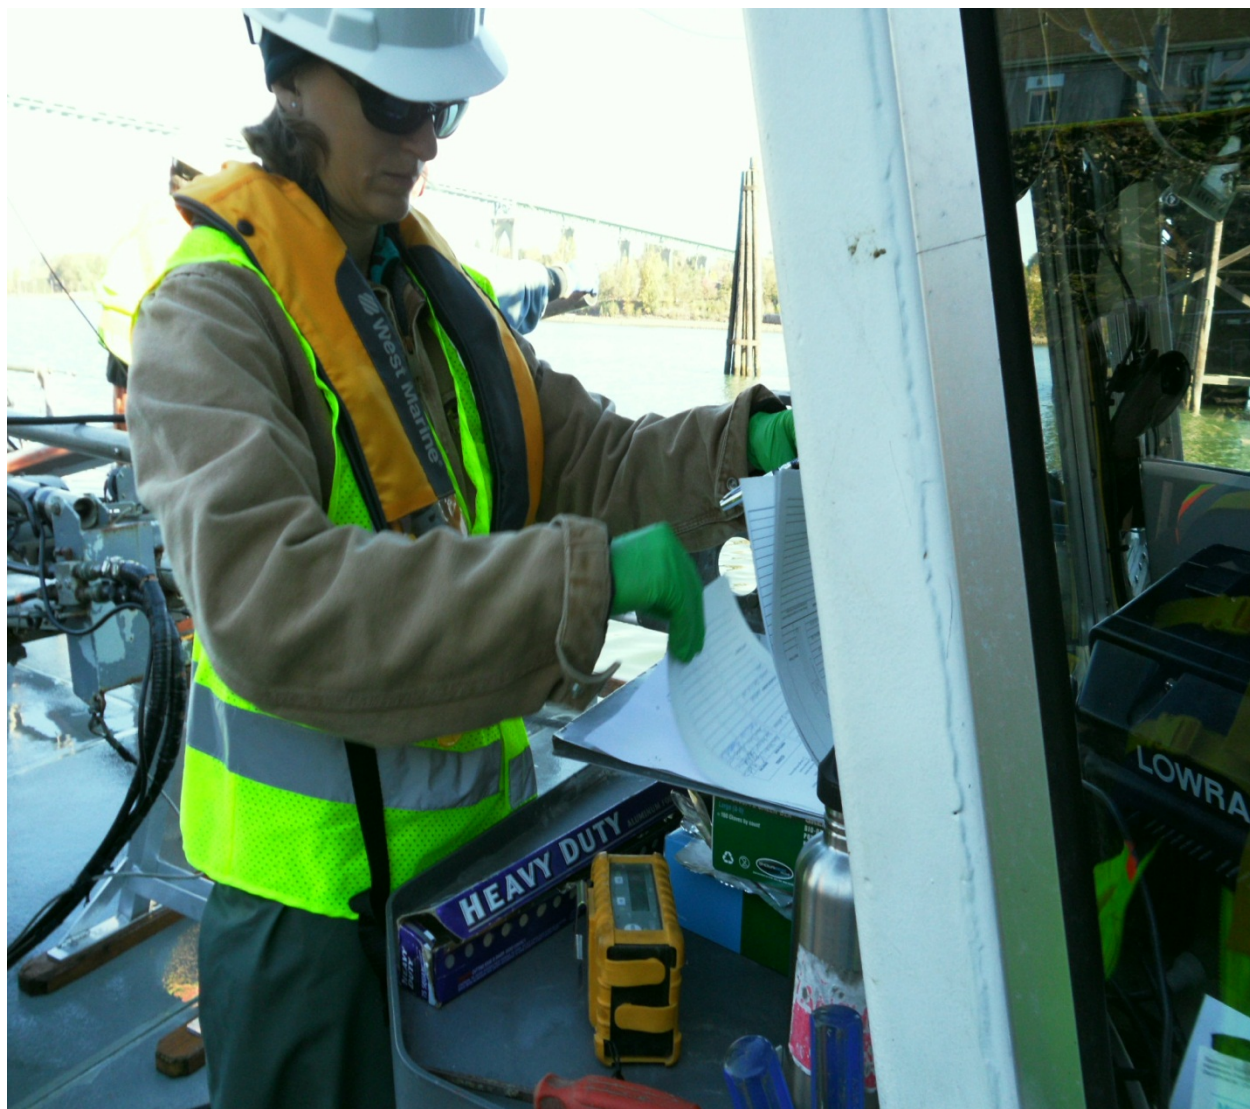
Photo 4: Crew logs sample information. Volatile organic compound (VOC) monitor in foreground.

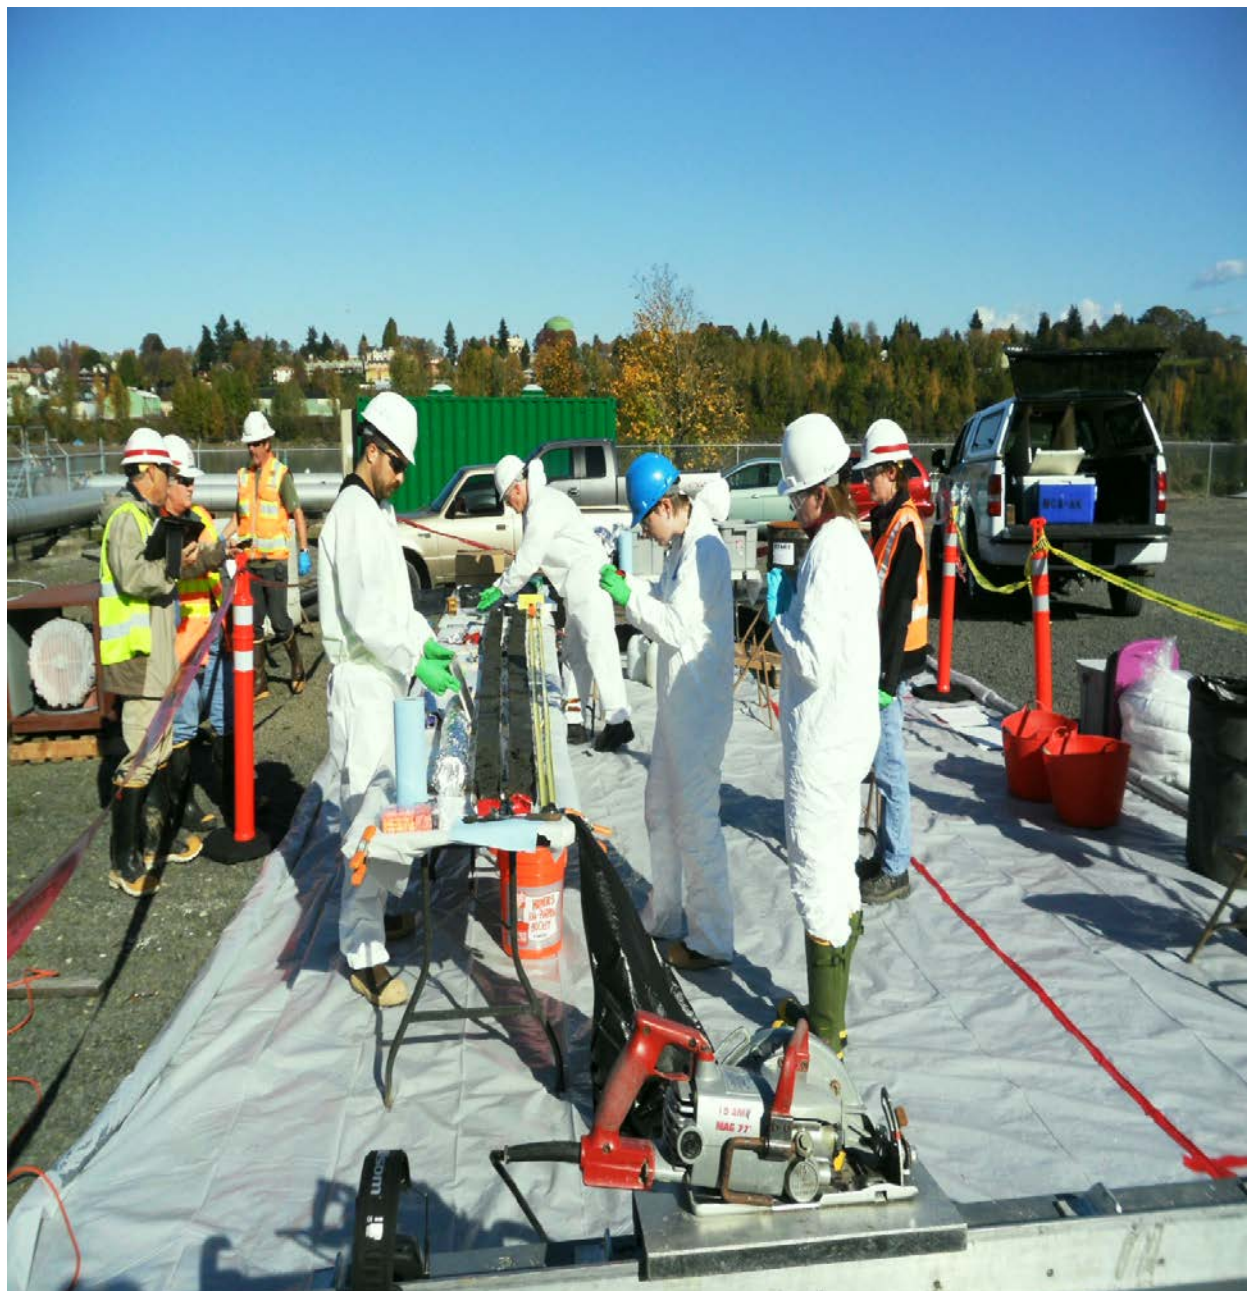
Photo 5 Anchor QEA personnel cutting sediment core tubes and processing core on the Gasco site upland.
